MISCELLANEOUS PAPER S-73-33

CONDITION SURVEY, GLASGOW AIR FORCE BASE, MONTANA

R. D. Jackson

May 1973

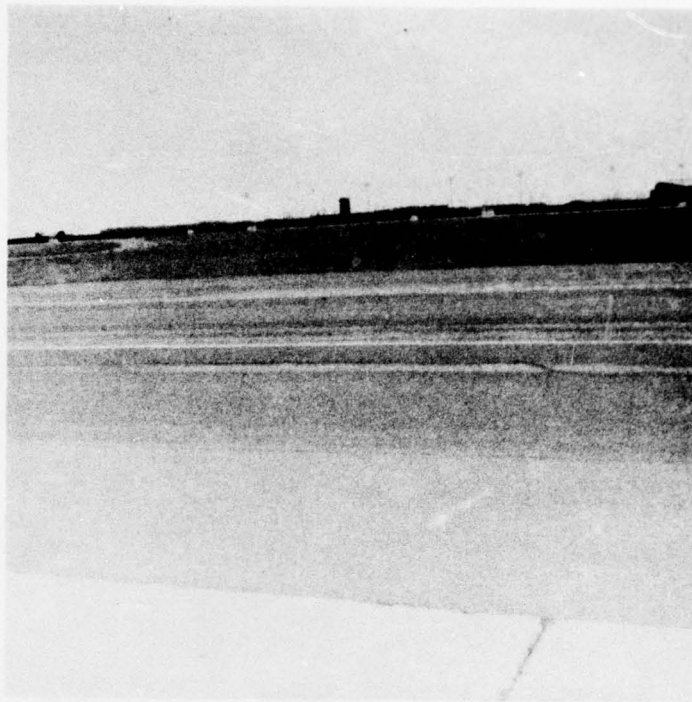
14. The portland cement concrete (PCC) pavement of the runway was in very good condition (except for two areas), even though the number of defects had increased considerably since the 1960 survey. The 17-in.-thick pavement from sta 78+75 to 88+75 was rated as being in poor condition, because the number of major defects had more than doubled since the 1960 survey. The 14-in.-thick edges of the runway ends (features R5D and R6D) were considered to be in poor condition. The flexible pavement edges of the runway interior (feature R8D), however, were considered to be in good condition (see photo 1).

Photo 1. General view of AC pavement of outer edge of runway interior (feature R8D) near sta 45+00

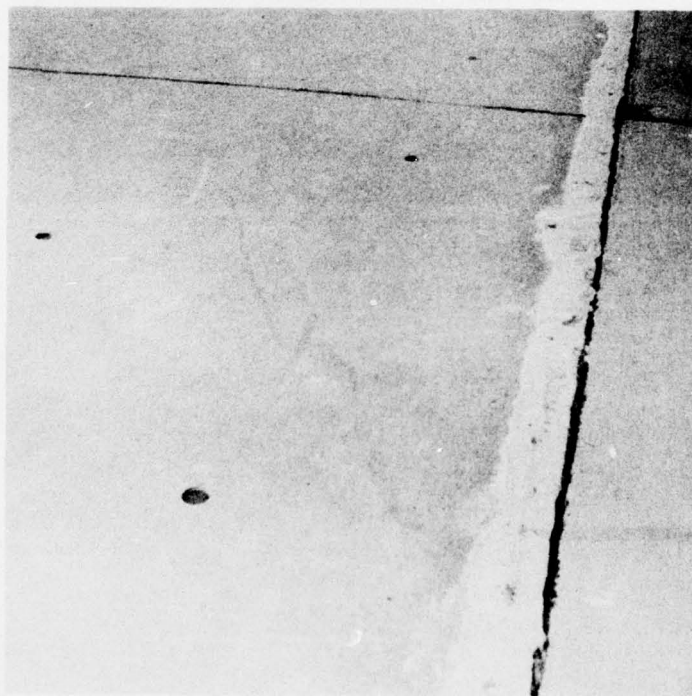
15. There was evidence of settlement of several slabs in the runway interior between sta 65+00 and 70+00 (feature R7C). It was reported that unsuccessful mud jacking had been performed in this area in 1966 and 1967. An epoxy surface patch approximately 115 ft long and 6 to 8 in. wide was installed to smooth out the transition area onto the settled slabs. There was no evidence that movement of these slabs had occurred since the installation of the patch. Photo 2 shows the condition of the patch. Numerous grouted drill holes (photo 2) were noted in runway features R3C and R4C, indicating that mud jacking had been performed at some previous time. Some settlement of slabs was noted near sta 45+00 (photo 3).

Photo 2. Epoxy patch and grouted drill holes

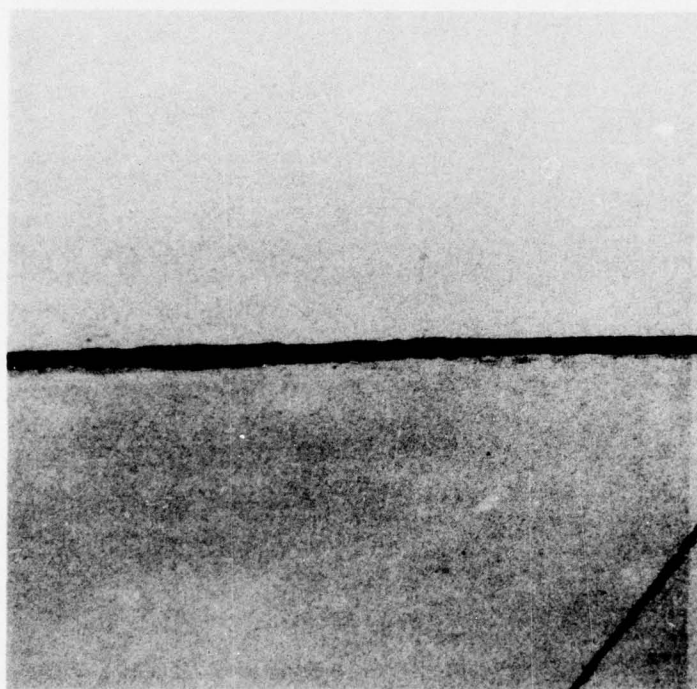
Photo 3. Settlement of slab near
sta 45+00 of runway
